# Public Water System Annual Report

Southwest Regional Water Treatment Plant & Southwest Regional Water Co-op 2023

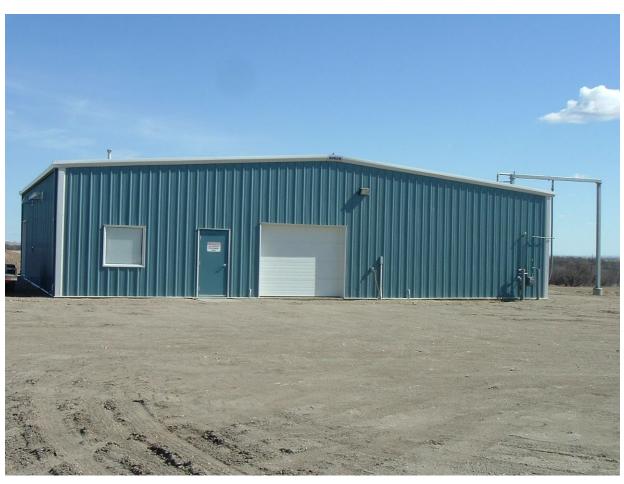
**The Melita Water Treatment Plant**

The Southwest Regional Water Co-op Public Water System (PWS) provides safe potable drinking water to the residents of Melita, Two Borders, Brenda, Napinka, Medora and Waskada through the distribution systems and to other rural residents by means of the Truck Fill System at the Water Treatment Plant (WTP). Treated water produced from the WTP meets or exceeds all health and aesthetic objectives as stated in the *Guidelines for Canadian Drinking Water Quality*.

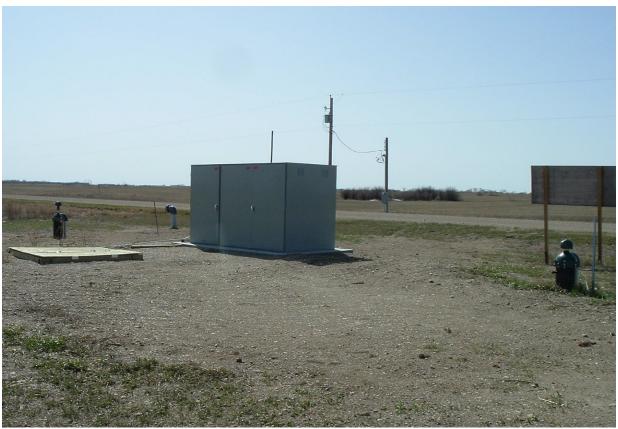
Well Site 1

The WTP receives groundwater from four wells located at 16 km North East of Melita @ NW23-5-27W. The wells draw groundwater from the Oak Lake Aquifer. The wells were drilled to a depth of 33 feet. Raw water pumped from the wells into a 200 mm (8 inch) pipeline where it flows directly into the WTP for processing and treatment.

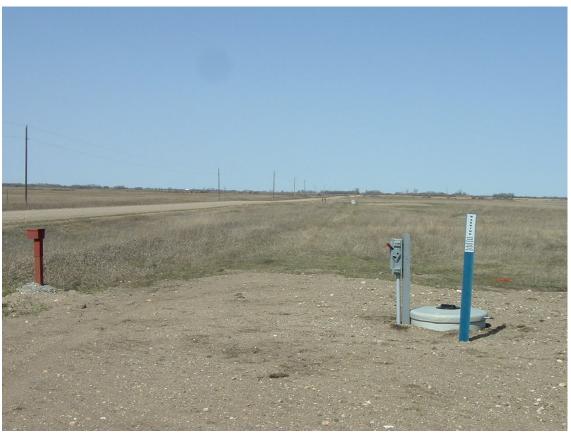
**Recharge Wells**

Since fall of 2017 we have not had to recharge the east site because we stopped pulling water from these wells and now only pull from the new ones at the East site.

Since the middle basin could only be pumped intermittently, the north basin well was temporarily equipped with a pump, generator, and overland pipeline to speed up the water table recovery. Pumping from this basin occurred from September 3<sup>rd</sup> to September 21<sup>st</sup> until water levels significantly recovered and the north basin water table prevented further pumping. The water table in the north basin has since recovered. In 2012 the north basin was converted to a supplemental well to improve operating pressures and flows to the plant when it is in operation.
